OSCILLATION WHEN ADJUSTING T4

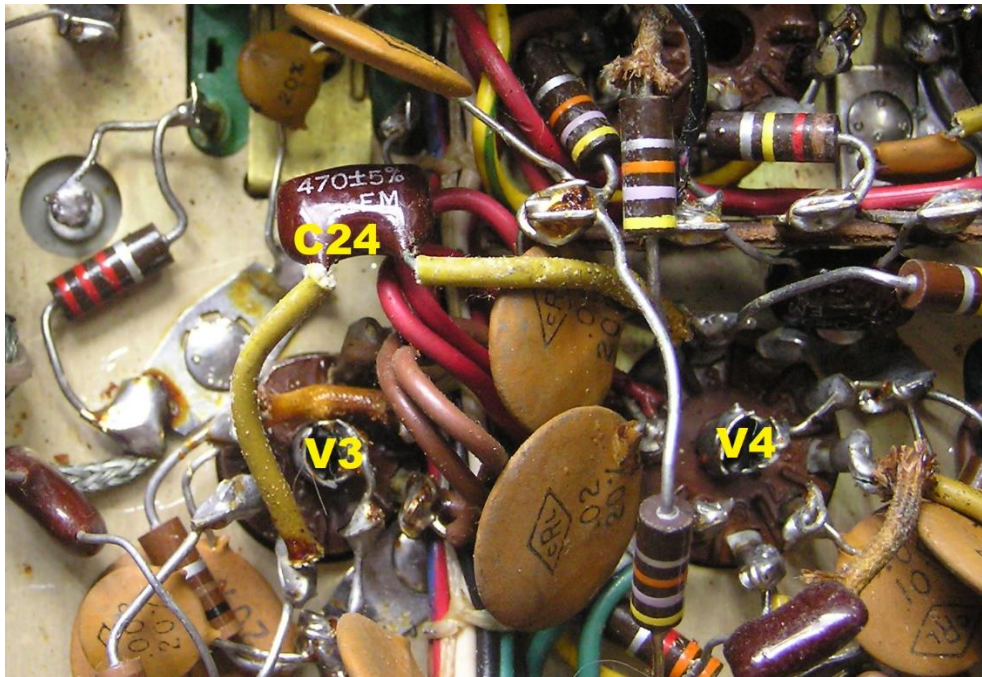
The position of C24 from the plate of V3 to the grid of V4 will cause an oscillation commonly referred to as motorboating. It manifests itself in one of two ways.

If the position of C24 is too close to the chassis or, too far away from the chassis the oscillation will occur. Corrosion in the chassis will intensify the effect. In the photo below the body of the capacitor is 5/8" away from the chassis. This is most common position for eliminating the fault.
