OSCILLATION WHEN ADJUSTING T3

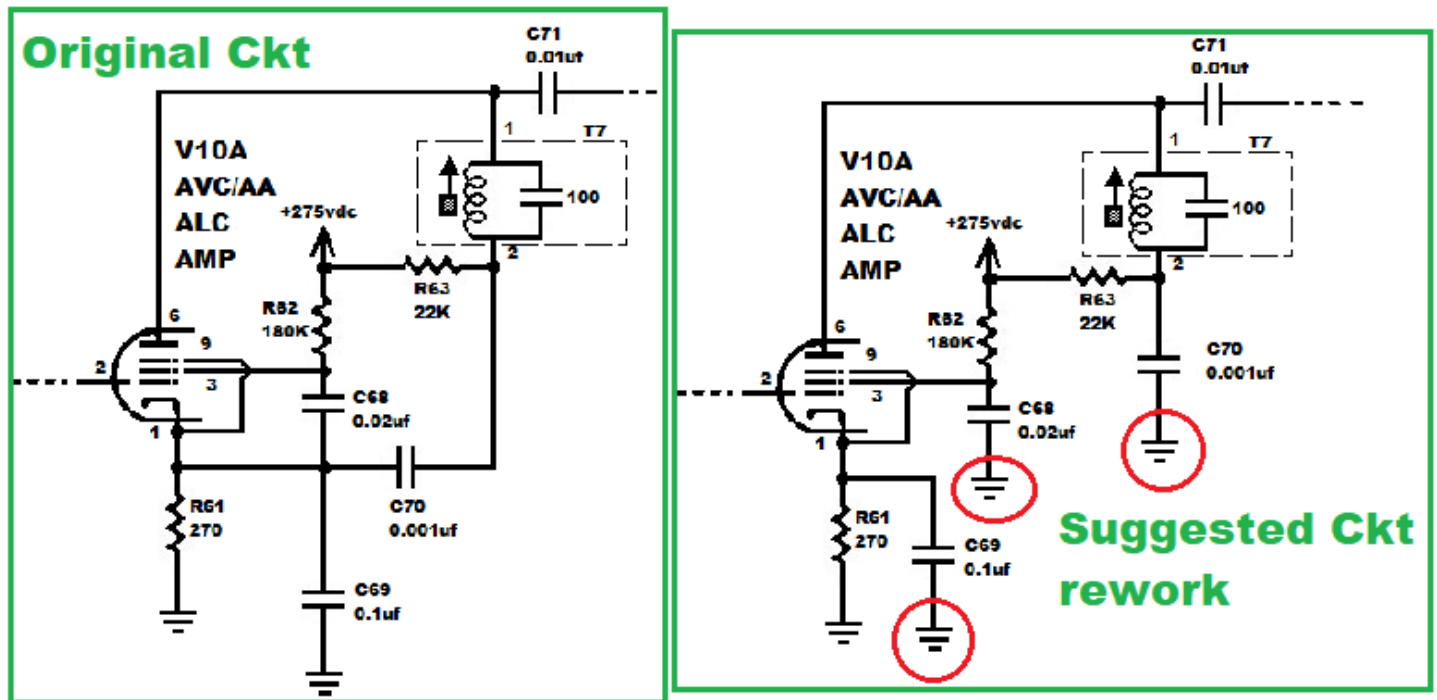
This is a “last resort” fix for the problem of motor-boating when T3 is peaked.

Replace C68, C69 and C70 with **Polyphenylene sulfide (PPS) film capacitors**. When replacing the capacitors reconfigure the grounds per the drawings.
