OSCILLATION WHEN ADJUSTING T3

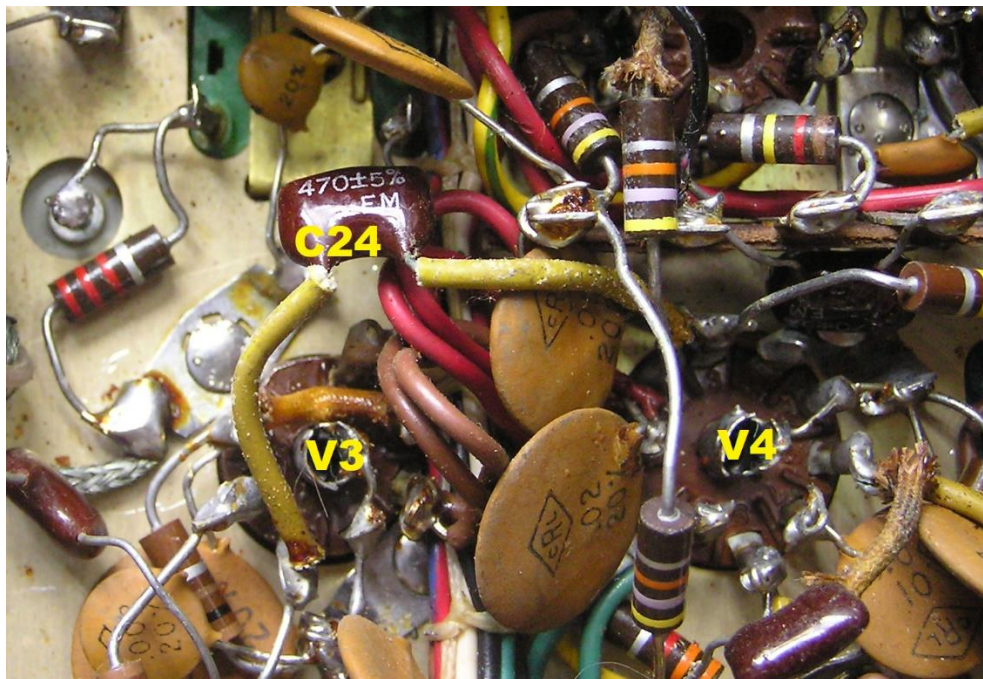
The position of C24 from the plate of V3 to the grid of V4 will cause an oscillation commonly referred to as motorboating. It manifests itself in one of two ways.

If the position of C24 is too close to the chassis or, too far away from the chassis the oscillation will occur. Corrosion in the chassis will intensify the effect. In the photo below the body of the capacitor is 5/8" away from the chassis. This is most common position for eliminating the fault.
