# Service Bulletin

BULLETIN 1963-2  
April 15, 1963

### BIAS ADJUSTMENT PROCEDURE FOR SR-150 COMMUNICATIONS TRANSCEIVER

### CIRCUIT REVISIONS IN THE SR-150 COMMUNICATIONS TRANSCEIVER

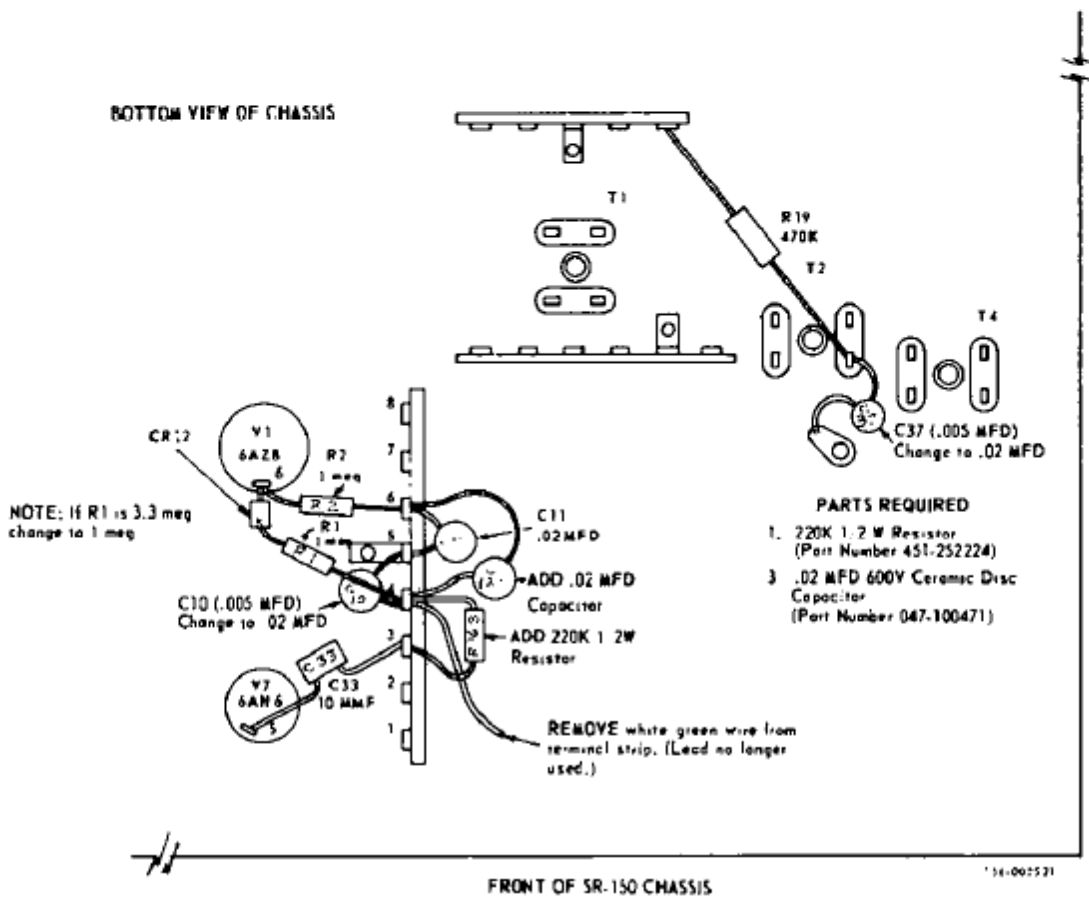
The following procedures outline the modifications necessary to remove the transmitted "click" from the SR-150 Transceiver, when switching from transmit to receive.

1. Remove white/green wire from terminal 4 of terminal strip near tubes V1 and V7. (Junction of R1, 1 megohm, and C10, .005 MF.)
2. Replace capacitor C10 (.005 MF) with a .02 MF disc capacitor. (Connected between terminals 4 and 5 of terminal strip.)
3. Add a .02 MF disc capacitor between terminals 4 and 6 of terminal strip.
4. Add a 220 K ohm, 1/2 watt resistor between terminals 3 and 4 of terminal strip.
5. Replace capacitor C37 (.005 MF) with a .02 MF disc capacitor. (Located at 6 MC IF can, T2.)
