THE INFAMOUS C100

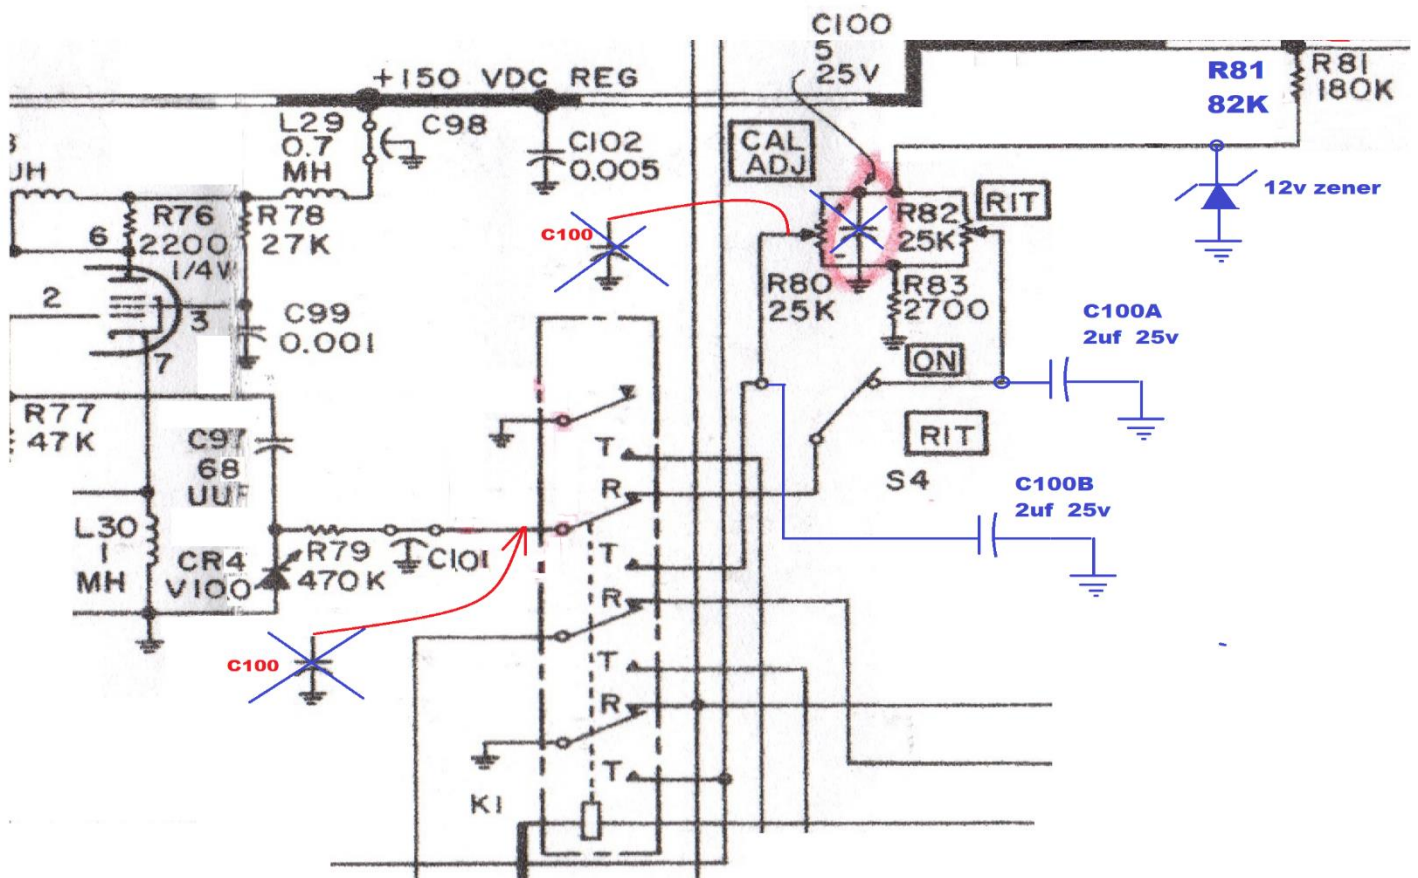
The infamous C100, It migrates all around the RIT circuit. Hallicrafters could not decide where they wanted to put it. It did not work connected to the tie-point of R81 and R80. It can be located at C101. Sometimes it is on the wiper of R80 the RIT control. Sometimes it is on the wiper of R82. **RED IN DRAWING BELOW**

The reason they wanted it in there was to decouple the line that feeds the VFO diode CR4. The wires run all over under the chassis and pick up a lot of noise, which would cause FMing of the VFO.

They tried different locations on the SR-160, SR-150, Cyclone, Cyclone II, 400A and the SR-2000.

When using the RIT feature in CW mode the capacitor caused a chirp on the first dit or dah. The best solution is to put a 2uf cap on each wiper OF R80 and R82.

I have found the best solution is a zener diode mod to the RIT circuit and splitting C100 between R80 and R82. **BLUE IN DRAWING BELOW**

Adding a zener diode at the junction of R80 and R82 provides a stable reference voltage for the bias divider. In addition, the zener establishes an extremely low impedance to gnd for any ac or rf induced into the wiring. The zener mod is in the sr-150 repair manual on <https://wd0gof.com> . Look for section 3-3-2.
